# TAR HEEL PIERING SYSTEMS, LLC

Project: Hunter Construction, Inc., Spruce Pine, NC.  
Structural Support for a State Employees Credit Union  
Contractor: Tar Heel Piering Systems  
Classification: ASTM-1143 Compression Test  
Project Date: October 24th, 2008  
Helical Piers Used: (129) 8-10 Starters,  
Installed to an average depth of 20'  
Total Installation Time: 5 Days

Re: Helical Pier Load Test Results  
State Employee Credit Union  
Spruce Pines, North Carolina  
ECS Project No. 31-1243

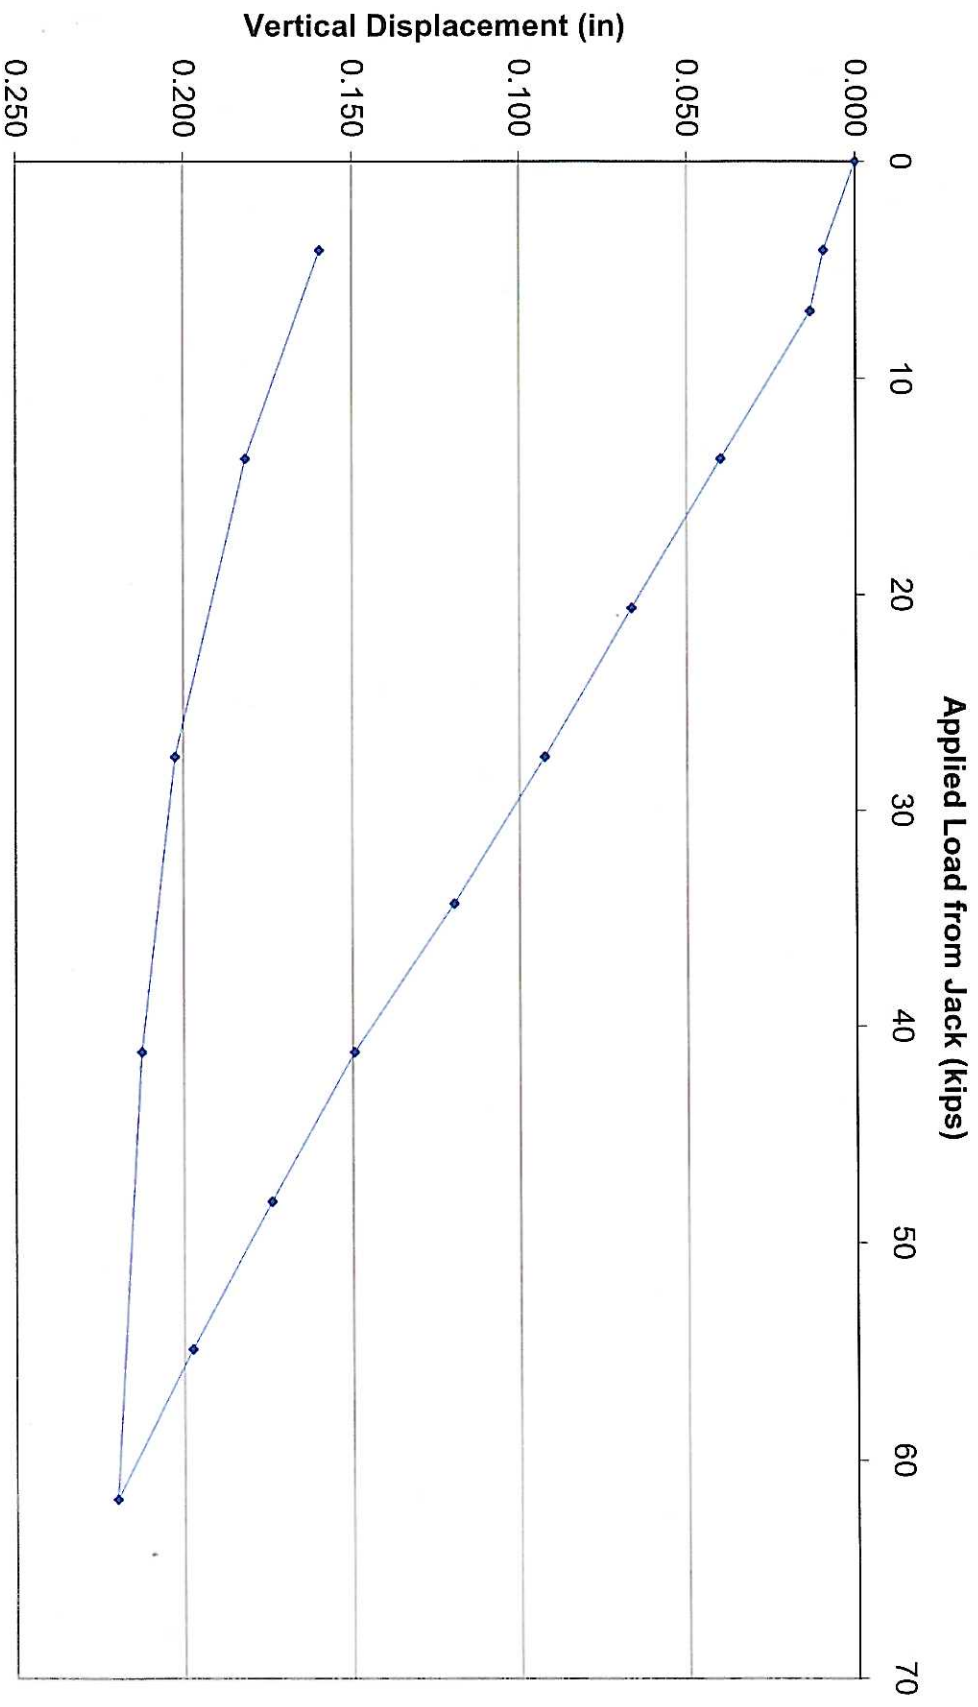
## Helical Pier Load Test (load-displacement plot)

The load test was performed in an area which consisted of residual micaceous silt overlying partially weathered rock based on the soil test borings provided in the geotechnical report dated November 23, 2005 by GeoTechnologies, Inc. The maximum measured vertical displacement from the top of the helical pier during the compressive load test was 1.145 inches, which occurred at the peak load of approximately 62.5 kips held for a total of 15 minutes.
